Corrosion Mitigation and Control at NASA Kennedy Space Center

**Janice K. Lomness, Ph.D.
NASA Kennedy Space Center**

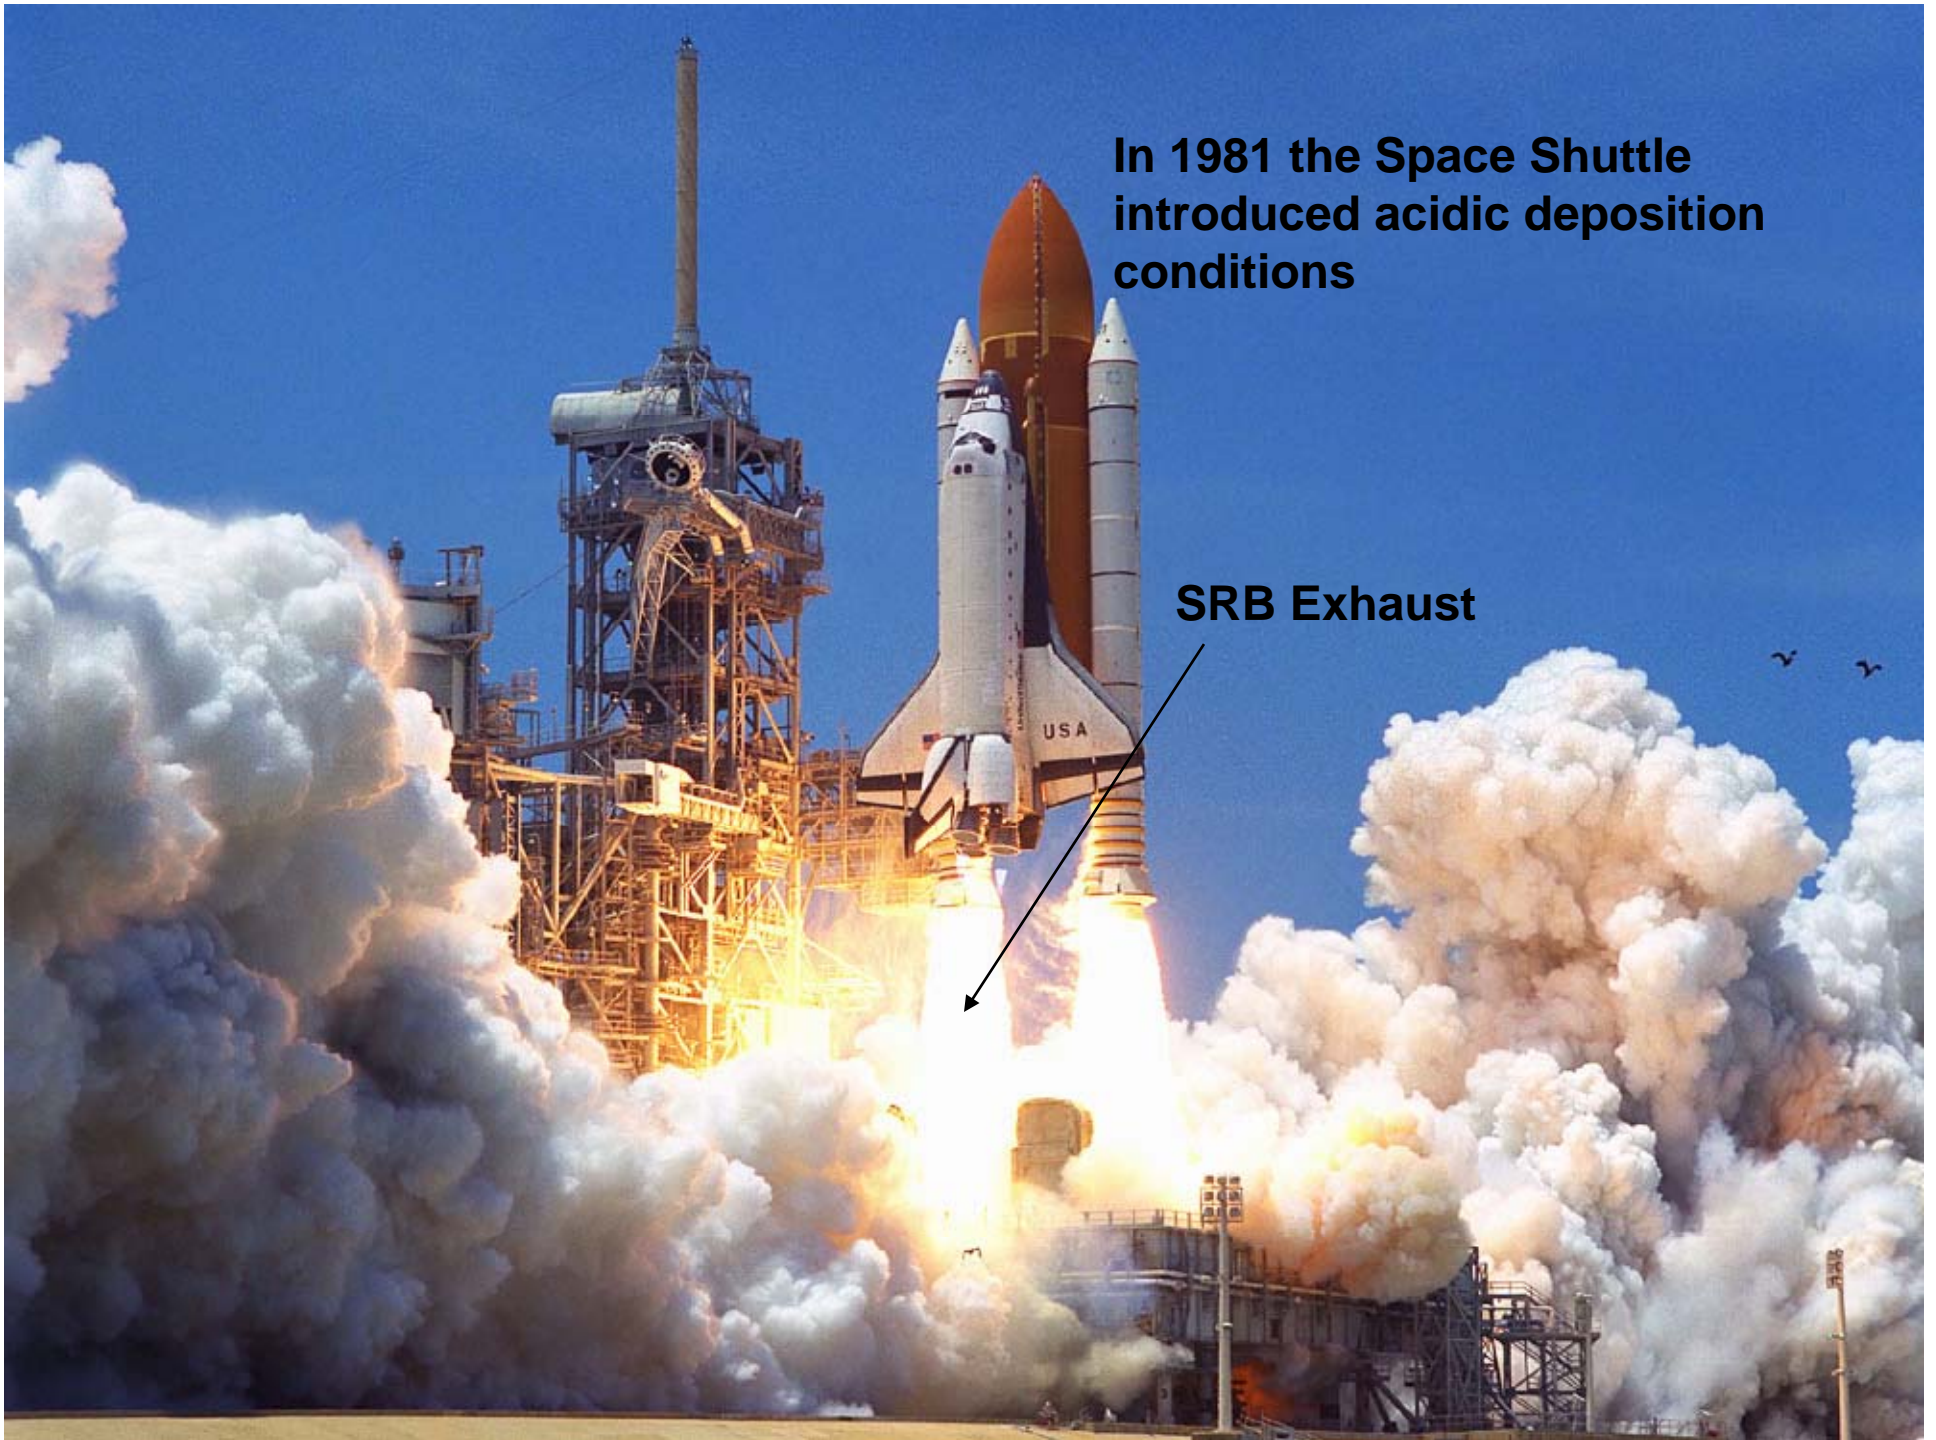
SRB Exhaust

**In 1981 the Space Shuttle
introduced acidic deposition
conditions**

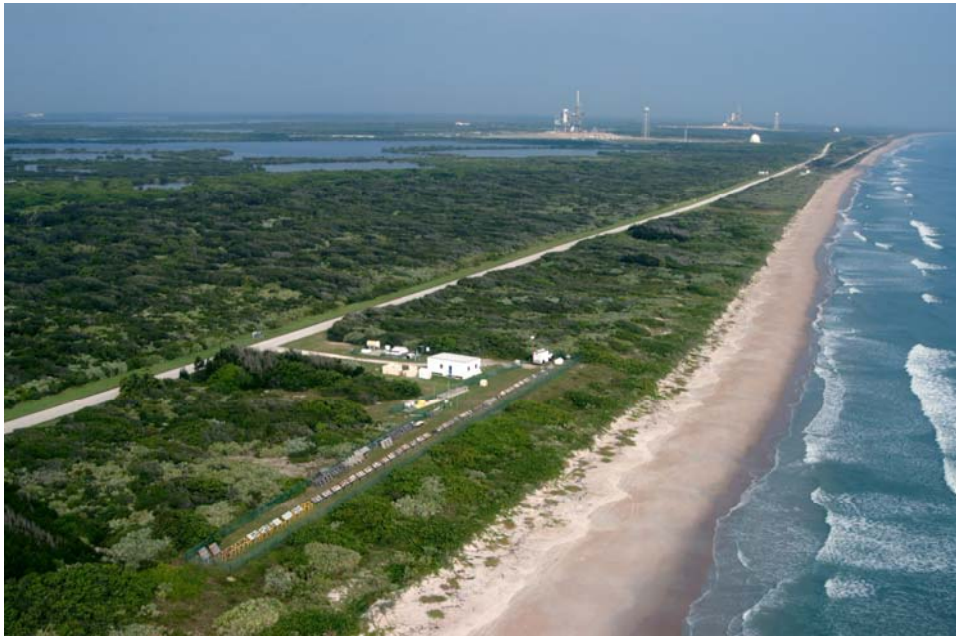
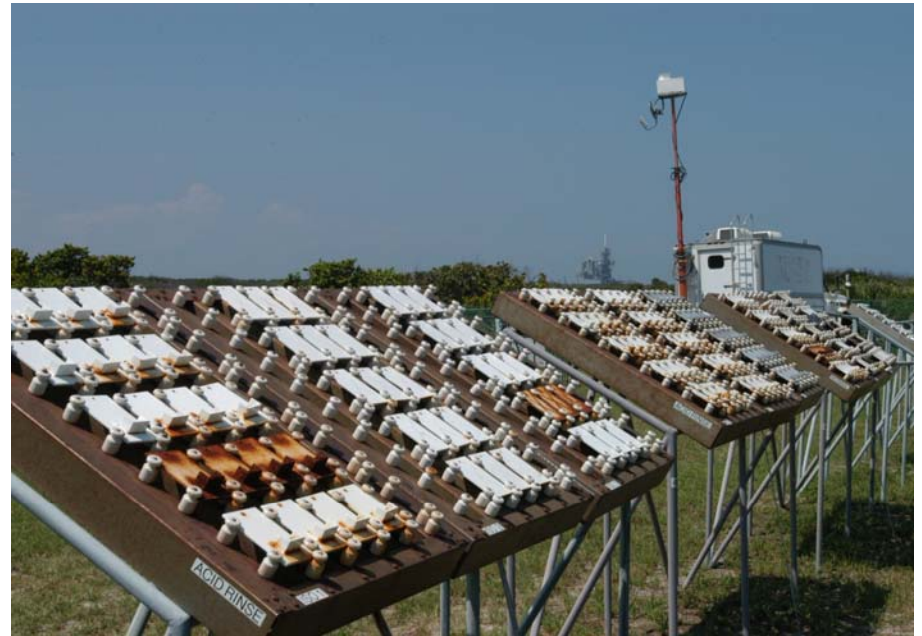
- **Atmospheric testing at the Corrosion Technology Atmospheric Test Facility**
